# McIntosh Industries Inc.

## **Gearless Hoist Motor Analysis**

Job # Car # 1

Job # Car 31

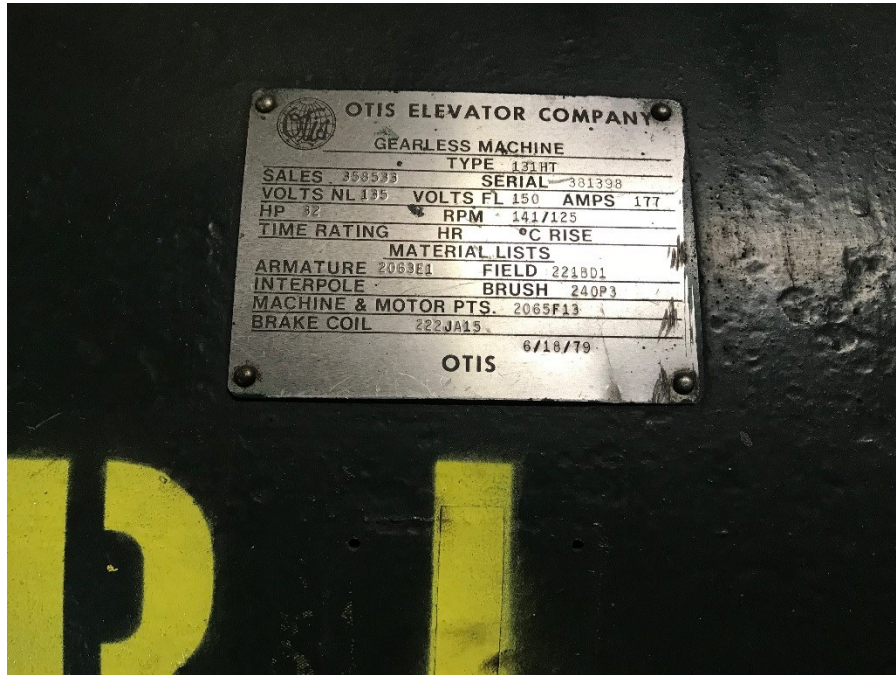
Car 1: Otis 131 HT name plate data tag.

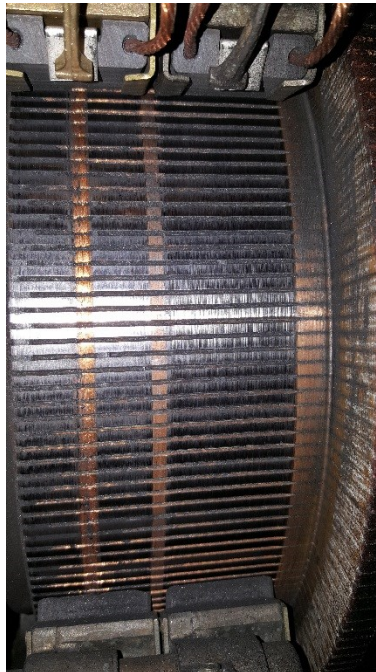
Arm	Winding	Heavy carbon buildup, Original		
	Commutator	<b>Dragovers</b> , Moderate brush surface wear, Stock > .800		
Fields	Wrap	Brittle but intact		
	Winding	Not Visible		
Interpoles		N/A		
Bearings		Condition	Clearance	Lubrication
Drive		<b>Slight Rumble</b>	Visually Good	<b>Slight Weeping</b>
Opposite		Quiet and Smooth	Visually Good	Visually Good
Brake Linkage		Visually Good	Brake Pads	Not Visible
Other:

Armature ground fault megger readings **LOW** prior to NitroClean™.  
 Armature retested March 23<sup>rd</sup> readings returned to original **LOW** readings.  
 Brush rig ground fault readings **LOW** prior to NitroClean™.  
 All other electrical results are acceptable after NitroClean™.

Dragover on commutator.

Remove Armature to the shop for repair	3
Replace Bearings	3-4

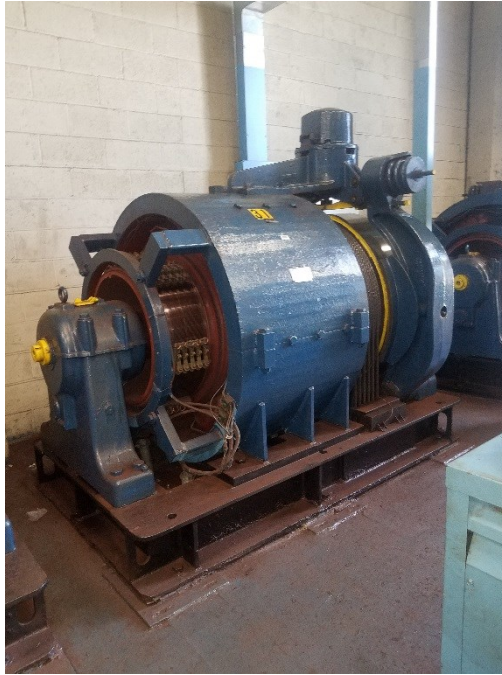
Car 31 Westinghouse 214 H.

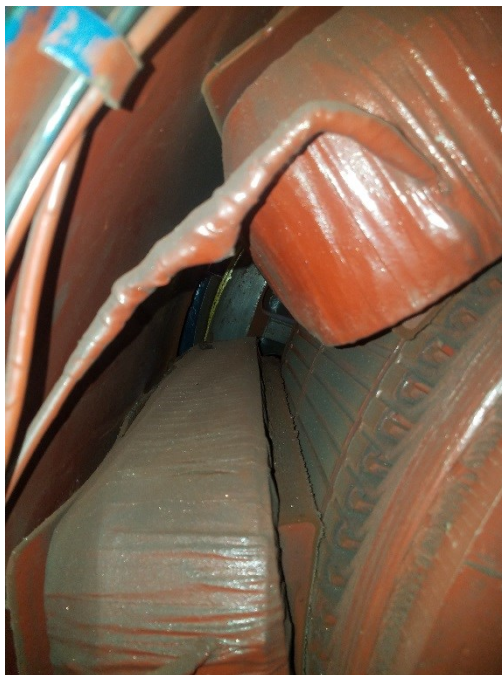
There was a moderate to heavy buildup of carbon dust throughout the machine prior to NitroClean™. Commutation is good. There is no sparking on acceleration, deceleration or during full speed operation. Brake linkage and pins are good. Pad thickness was acceptable. Heavy rouge condition throughout the machine.

Heavy carbon buildup throughout the machine prior to NitroClean™.

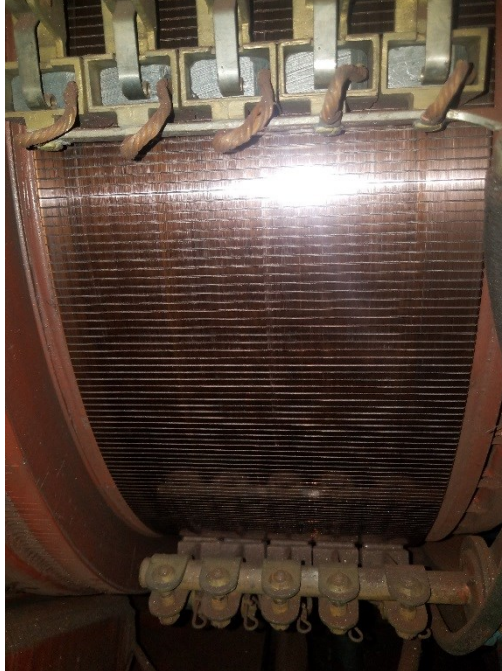
Arm	Winding	Original, visually good		
	Commutator	Visually good, carbon packed, commutator stock > .200*		
Fields	Wrap	Visually good		
	Winding	Not Visible		
Interpoles		N/A		
Bearings		Condition	Clearance	Lubrication
Drive		Quiet and Smooth	Visually Good	Weeping Seals
Opposite		Quiet and Smooth	Visually Good	Weeping Seals
Brake Linkage		Visually Good	Brake Pads	L > .260 R > .200
Other: Heavy rouge condition throughout the machine. *To top of equalizer winding.

Commutator visually good.

Turndown and Undercut	4-5
Replace Seals	3
